Dan Crowley\*, Fred Preis\*\*, Peter Windmüller\*\*, Titan Pennsuco,\* AirStream Systems Inc.\*\*

## Raw mill fan upgrade at Titan Pennsuco

Titan's 6000hp raw mill fan was upgraded by AirStream in 2008. This joint paper describes how its improved design has provided a large efficiency increase and a greatly reduced wear rate, as well as reduced the need for heavy maintenance. As a result, the project also won the Global Fuels 2009 Most Innovative Technology for Electrical Energy Efficiency Award.

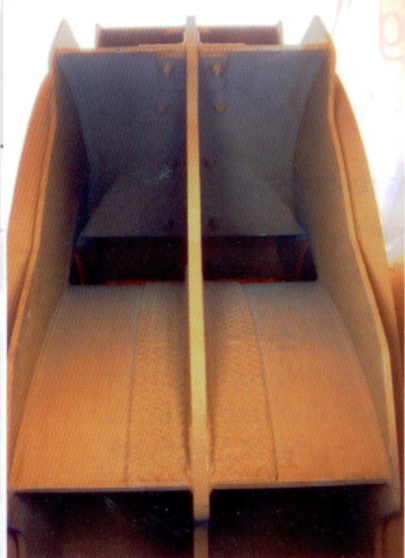
**Figure 1 (right):** AirStream's rotor upgrade.

The new rotor has a diameter of 3.6m, is wider and has larger inlet areas, resulting in much lower dust velocities. All surfaces subject to wear are fully protected with liners.

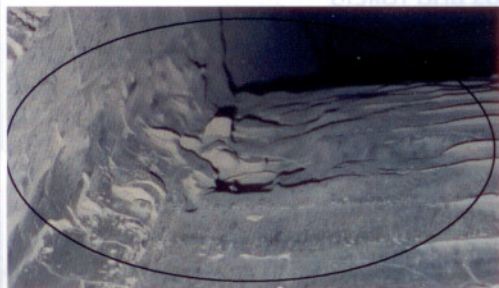
**Figure 2 (below):** The original fan rotor in 2004. The lack of sufficient wear protection was a primary factor in its failure.

At the Pennsuco site, AirStream examined the raw mill, preheater and coal mill fans. The findings indicated that all fan rotors would need some improvements if they were to attain a reasonable life. In particular, the raw mill fan was identified as the most likely to need repairs before completing the first year of operation. As shown in Figure 2, wear protection was minimal and consisted of partial liners of ribbed plate. The gas velocity in the rotor inlets was extremely high and topped 13,000fpm.

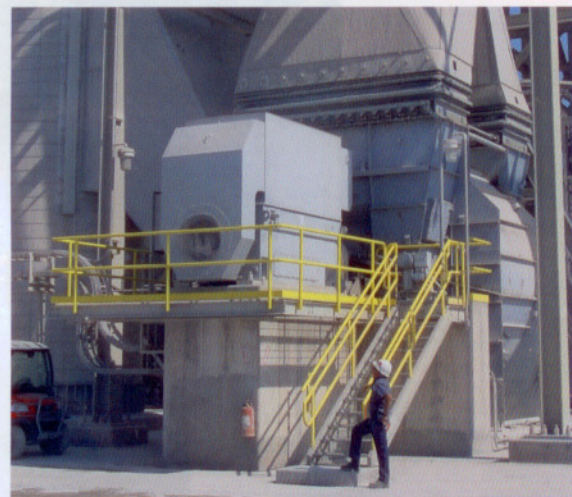
**Figure 3 (Above):** Repaired original fan rotor in 2006. It is clear from the image that there was a significant wear problem.

Wear rates are proportional to the square of the dust velocity and as a result, wear during the first year of operation (2004-2005) was severe. Uneven material loss often caused the fan vibration levels to rise above normal. Over the course of several repairs, the liners were changed to chromium carbide (CrC) and increased in size, and structural reinforcements were added to the blades as recommended by AirStream. Nevertheless, the fan still required monthly weld repairs to manage the wear (Figure 3).

Throughout 2006-2007, frequent repairs of the CrC surfaces continued. In late 2007, Titan contracted Air-

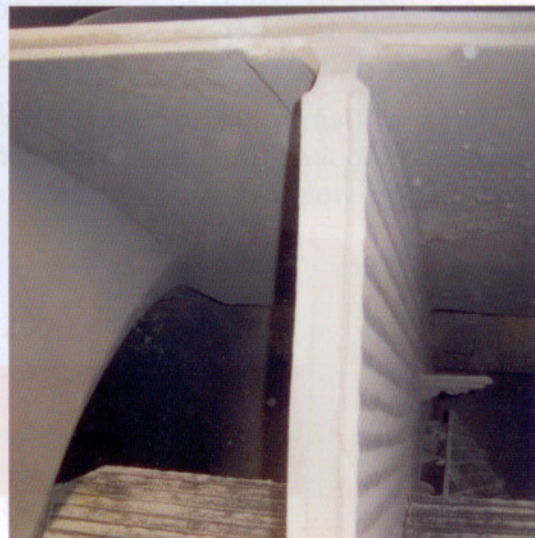
**Figure 4 (Right):** The AirStream Rotor in 2009 after 10 months of operation showed virtually no wear.

In 2009, after 10 months of operation, the fan rotor was inspected by Titan and AirStream. Virtually no wear was evident (Figure 4). Titan concluded that: "This was an excellent investment for the company. We saved what we expected, and the maintenance people love the equipment as it does not need heavy maintenance!"
